# Analysis of Road Damage Levels Using the Surface Distress Index Method and Handling Cracked Roads

Analysis of the Level of Road Damage Using the Surface Distress Index Method and Evaluation and Handling of Cracked Roads (Case Study: Jalan Ciherang Cutak-Jalan Suka Mulya, Ciomas District, Bogor Regency. The existence of roads is very necessary to support the rate of agricultural and other economic growth, considering the important benefits So the road construction and maintenance sector is a priority for research and development in planning, implementation and maintenance. The road sections experienced damage which includes several factors such as road sections that are frequently used, poor drainage channels. The aim of this research is to determine the type of damage, evaluate and handle damage to road sections, as well as obtain damage values on Jalan Ciherang Cutak-Jalan Suka Mulya, Ciomas District, Bogor Regency based on the parameters of the Surface Distress Index (SDI) method. The length of the road used in this research is  $\pm 1000\text{m}$  which is divided into 10 segments with The length of each road is  $\pm 100\text{m}$ . In this research the author used the Surfac

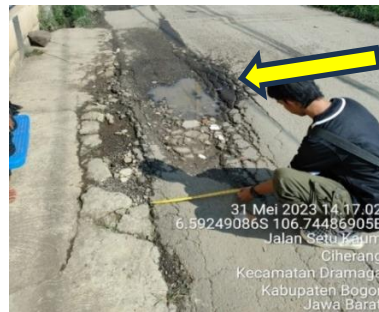
**Figure 4.** Pavement Edge Defects at Sta 0+100. Source: Research data

Figure 4 is the result of documentation of the types of damage that occurred on the road pavement of Jalan Ciherang Cutak - Jalan Suka Mulya, Ciomas District, Bogor Regency, namely defects in the edge of the pavement surface and the shoulder of the dirt road or on the edge of the shoulder of the asphalt road and the soil around the asphalt.

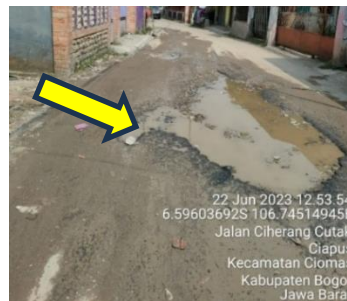
**Figure 5.** Holes 0+300 - 0+400. Source: Research data

Figure 5 is the result of documentation of the type of damage that occurred on the pavement of Ciherang Cutak - Jalan Suka Mulya, Ciomas District, Bogor Regency, namely holes causing surface cracks and grain release or both. In this study, cracking then occurred in wide cracks followed by the release of aggregate material at the edge of the crack due to traffic loads.

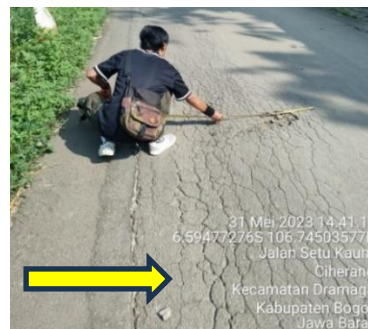
**Figure 6.** Crocodile Crack 0+500 - 0+600. Source: Research data

Figure 6 is the result of documentation of the type of damage that occurred on the pavement of Ciherang Cutak - Jalan Suka Mulya, Ciomas District, Bogor Regency, namely that crocodile cracks can occur due to poor pavement materials, poor subgrade, weathering of the ground surface or the pavement below. The surface layer is less stable and the road surface is unable to withstand the weight of traffic vehicles.

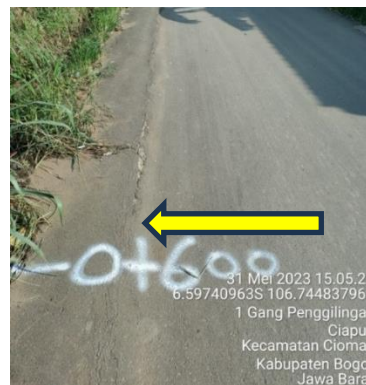
**Figure 7.** Longitudinal crack 0+600 - 0+700. Source: Research data

Figure 7 is the result of documentation of the type of damage that occurred on the pavement of Ciherang Cutak - Jalan Suka Mulya, Ciomas District, Bogor Regency, namely that longitudinal cracks can occur due to reflection cracks, if the asphalt layer is carried out on a cement foundation layer including soil-cement and with cement stability, The asphalt layer will crack due to reflection.
