## Analysis of the Level of Landslide Susceptibility in the Sakuli Latambaga Area, Southeast Sulawesi

### ABSTRACT

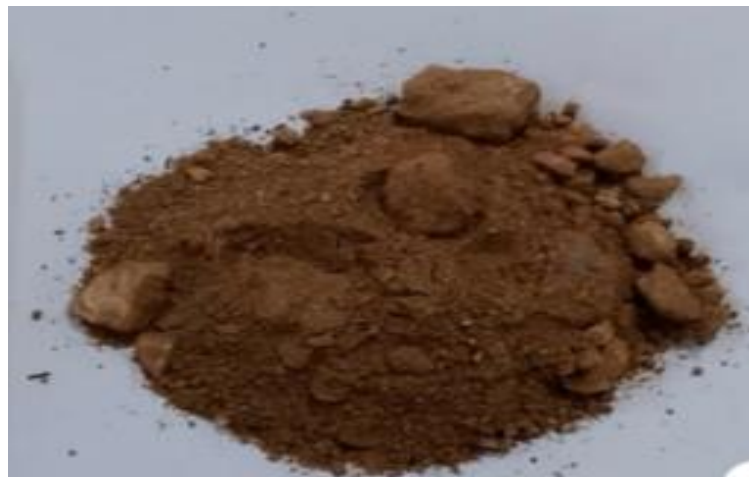
Based on analysis of soil samples in Kolaka, it was found that there were three types of soil texture at the research location, namely clay, dusty clay, sandy clay. Meanwhile, in the research area with the characteristics we can feel the sand content when holding the soil, it tends to be looser and scattered with a little clay and smoothness, has a lighter color, such as light brown or light gray so it can be concluded that the research area has a texture sandy loam soil (Armiselin Ch.Salawangi, 2020). For more details, see Figure 1.

**Figure 1.** Soil texture conditions at the research location (Source: Researcher 2023)

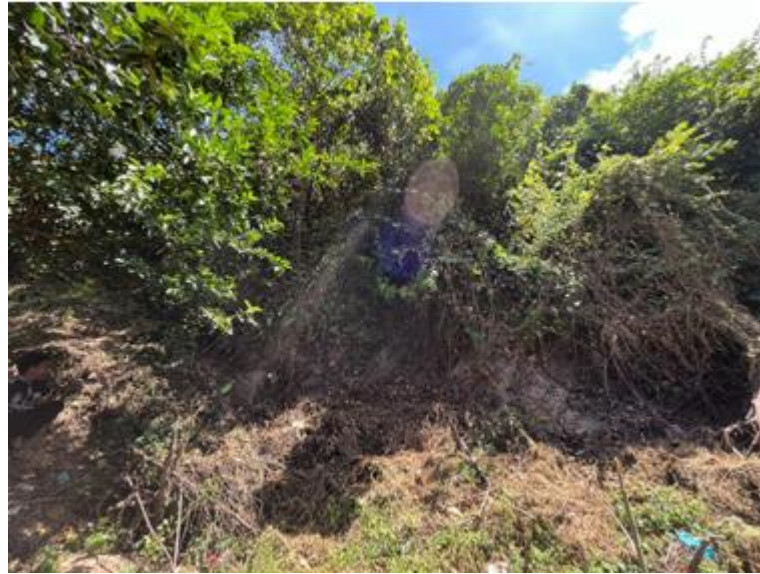
Regolith The condition of rock material resulting from weathering which causes very hard rock to change into softer material or finer grains. Based on Figure 2, it is clear that the grains of the rock weathering material in the study area are still clearly visible.

**Figure 2.** Soil texture conditions at the research location (Source: Researcher 2023)

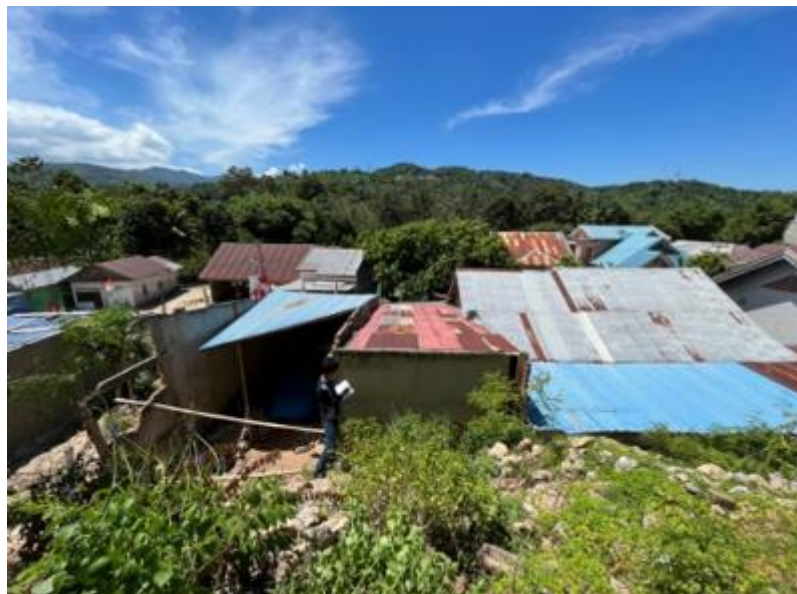
Currently, land use in Kolaka Regency is still dominated by natural forests, plantations and settlements. Meanwhile, the land use research locations are settlements and plantations. For more details, see Figure 3.

**Figure 3.** Land Use at the research location (Source: Researcher 2023)

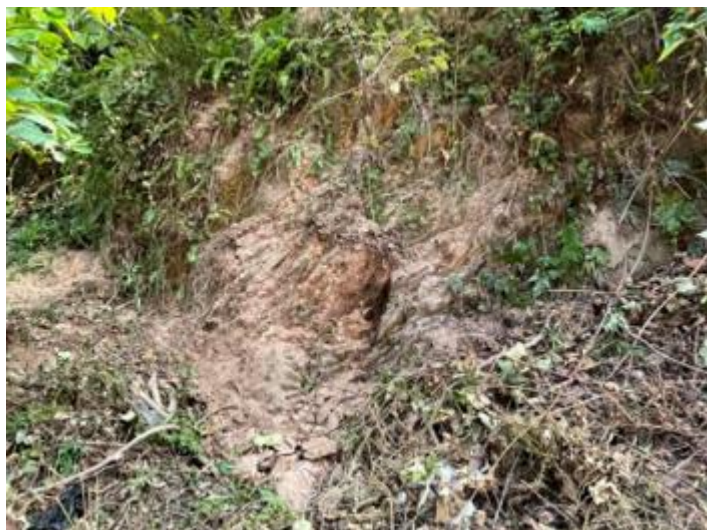
An overview of the geological conditions in the Kolaka Regency area, in this case seen based on geomorphological units, rock-forming units and geological structures. Where the rocks that make up the research area are metamorphic rocks with physical characteristics, fresh brown, weathered blackish gray, lepidoblastic texture with a foliation structure. Meanwhile, the morphological condition is steep with the type of structure found in the form of folds, thus identifying that in the study area there are faults that are still active (Figure 4).

**Figure 4.** Geological conditions and fold structures at the research location (Source: Researcher 2023)
