IoT-Based Pedestrian Performance Evaluation at Tegar Beriman Street

ABSTRACT

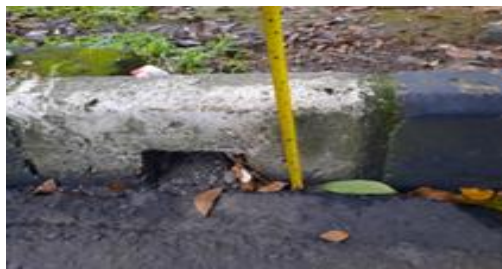
Field observations conducted in front of the PDAM TK revealed a sidewalk height of 19 cm. The recommended sidewalk height for arterial or collector roads with high traffic volumes is 15-20 cm. Therefore, the sidewalk height at the study location aligns with the established standards [2].

Figure 3. Sidewalk height Source: personal documentation 2025

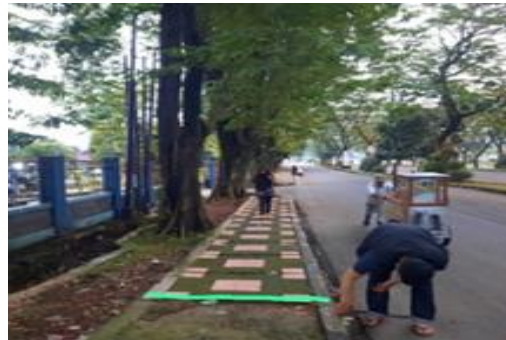
Observations conducted in front of the PDAM TK revealed a sidewalk width of 200 cm. The minimum effective width for two wheelchair users or two adults to pass each other is 185 cm. Therefore, the sidewalk width at the study location meets the standard for the effective width of a pedestrian pathway [2].

Figure 4. Pedestrian width Source: personal documentation 2025
