# Analysis of Road Damage Levels Using the Surface Distress Index Method and Handling Cracked Roads

Analysis of the Level of Road Damage Using the Surface Distress Index Method and Evaluation and Handling of Cracked Roads (Case Study: Jalan Ciherang Cutak-Jalan Suka Mulya, Ciomas District, Bogor Regency. The existence of roads is very necessary to support the rate of agricultural and other economic growth, considering the important benefits So the road construction and maintenance sector is a priority for research and development in planning, implementation and maintenance. The road sections experienced damage which includes several factors such as road sections that are frequently used, poor drainage channels. The aim of this research is to determine the type of damage, evaluate and handle damage to road sections, as well as obtain damage values on Jalan Ciherang Cutak-Jalan Suka Mulya, Ciomas District, Bogor Regency based on the parameters of the Surface Distress Index (SDI) method. The length of the road used in this research is  $\pm 1000\text{m}$  which is divided into 10 segments with The length of each road is  $\pm 100\text{m}$ . In this research the author used the Surfac

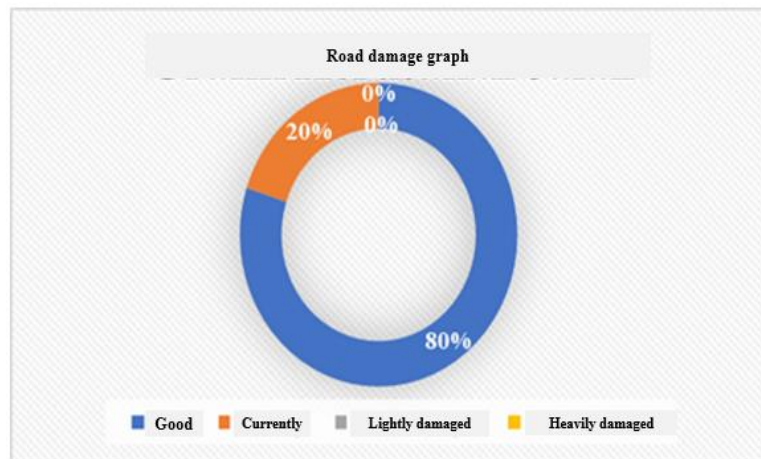
**Figure 8.** Road Damage Graph

From table 4 above, the average surface distress index (SDI) value is 35 with good road conditions. However, there are several damaged segments with moderate conditions at STA 0+500. The following are graphic results of road conditions.

The results of the graph above are the results of dividing the percentage (%) for each condition of damage, namely good condition 80%, moderate 20%, slightly damaged 0% heavily damaged 0%.

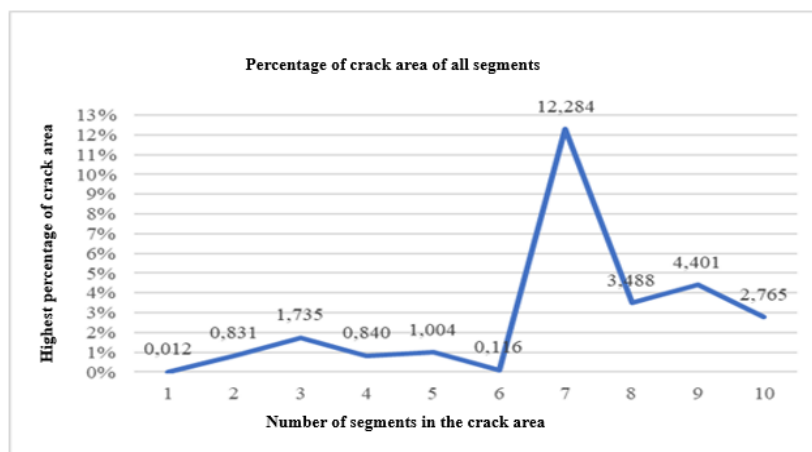
**Figure 9.** Results graph of crack area in all segments.

The graph above shows the value of the area of cracks on Jalan Ciherang Cutak- Jalan Suka Mulya, showing the large number of crack areas from segments 1 to 10. However, the largest number of crack areas is shown in segment 7 with a crack area value of 12.2%.

Segment	Number of Cracks	Crack Extent	SDI value 1	Crack Width	SDI value 2	SDI value	Handling
1	5	0,0124	5	1,546	10	25	Routine Maintenance
2	4	0,831	5	2,288	10	25	Routine Maintenance
3	3	1,735	5	0,933	10	25	Routine Maintenance
4	4	0,840	5	0,808	10	25	Routine Maintenance
5	3	1,004	5	0,417	10	85	Periodic Maintenance
6	3	0,116	5	0,233	10	25	Routine Maintenance
7	2	12,284	20	0,775	40	55	Periodic Maintenance
8	1	3,488	5	0,600	10	25	Routine Maintenance
9	3	4,401	5	0,517	10	25	Routine Maintenance
10	4	2,765	5	0,900	10	25	Routine Maintenance
