Seismic Performance of Simple Reinforced Masonry Houses with Brick Walls: Experimental and Numerical Approaches

ABSTRACT

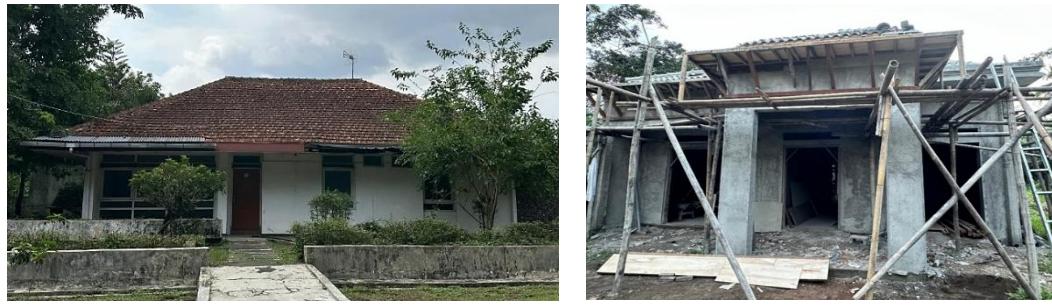
a. Existing condition of House A

b. Existing condition of House B

Figure 2. Existing condition of House A (a) and House B (b)

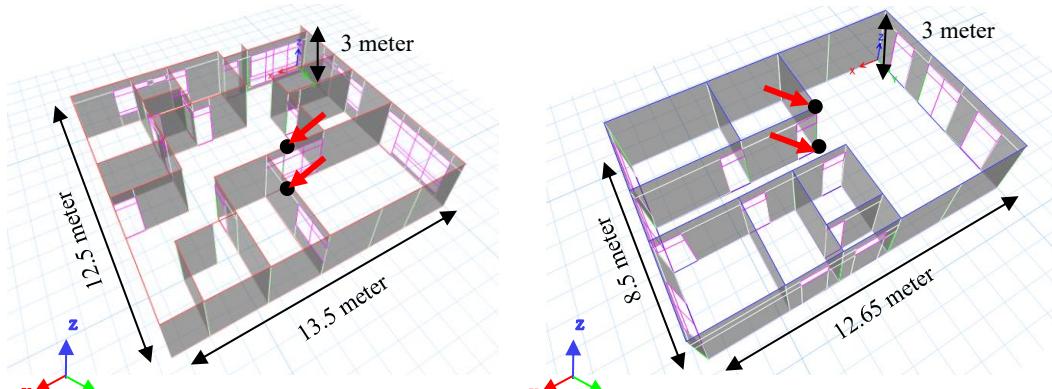
a. Position of the sensor at House A

b. Position of the sensor at House B

Figure 3. The position of the sensors in House A (a) and House B (b)

The measurements were conducted on House A and House B using a PCB accelerometer with a sensitivity of 1000mV/g and installed on the ring beam and ground floor to record the vibration response of the building. This position contributes to the stiffness and stability of the building. The ring beam can detect lateral deformation and global behavior of the structure, while the ground floor reflects the overall movement of the structure against the ground. The existing condition of the houses and the specifications of the sensor positions for both houses can be seen in Figure 2 and Figure 3. The data obtained include the acceleration and natural frequency of the building for 5 minutes, which are then analyzed to identify the dynamic characteristics of the building structure [9]. The frequency used is the average of the frequencies observed at the ring beam and the base. Vibration recordings were conducted in two principal directions to analyze the dynamic response of the building structure to earthquake loads. The X direction is defined as the longitudinal direction of the building, which is parallel to the longest side of the structure, while the Y direction is the transverse direction, perpendicular to the X direction. Before the measurements began, the accelerometer was calibrated to ensure a zero reading when the instrument was motionless.

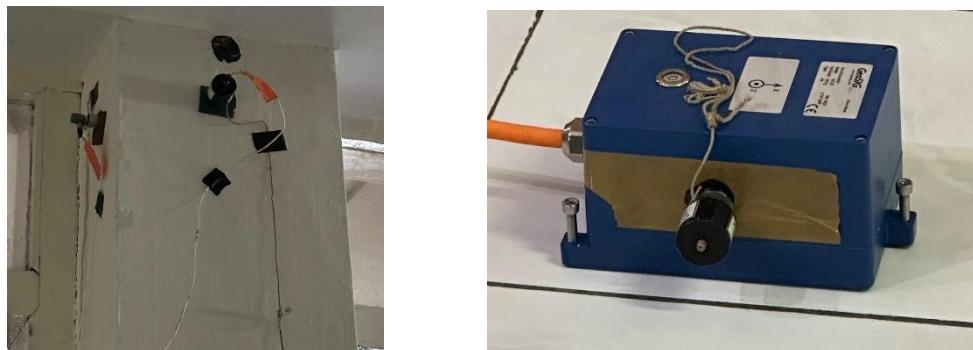
a. Position of the sensor on the ring beam

b. Position of the sensor on the base

Figure 4. The position of the sensors on the ring beam (a) and base (b)

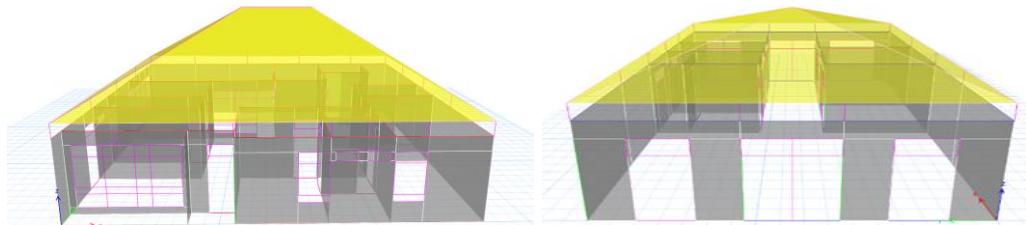
a. Structural modeling of House A

b. Structural modeling of House B

Figure 5. Structural modeling of both measured houses

Numerical modeling using Finite Element Method (FEM) was carried out based on the accurate data of the houses in the field, including dimensions and material characteristics (see Table 1). The structure was modeled using a finite element approach, where the masonry walls were represented by shell elements (see Figure 5). Both houses used masonry materials with a concrete quality of 20 MPa [6] and an elastic modulus of 1500 MPa [11].

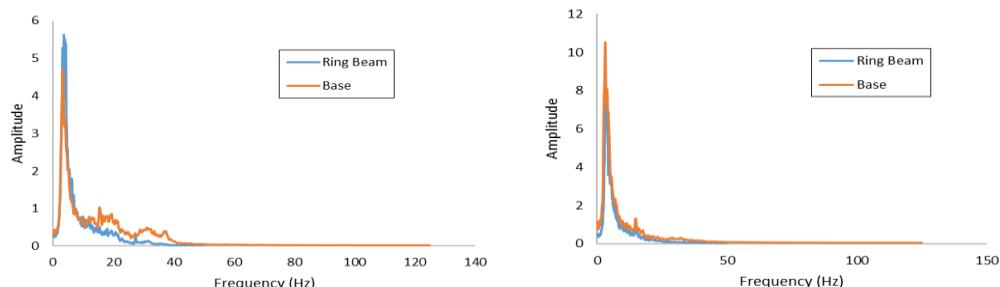
(a) Longitudinal dominant frequency graph (b) Transverse dominant frequency graph.

Figure 6. Longitudinal (a) and Transverse (b) dominant frequency graphic at House A

The natural frequencies of the buildings were obtained through field testing using accelerometers and numerical modeling. The analysis results show an acceptable agreement between the natural frequencies obtained from both methods, with the differences between the results of field measurements and numerical simulations (see Table 4). Graphic average frequency longitudinal and transverse can be seen Figure 6 and Figure 7. These differences can be caused by several factors, including model idealization, assumptions of placement conditions that may differ from actual conditions, and uncertainties in material parameters such as elastic modulus and structural mass. Nevertheless, the results of this comparison indicate that numerical modeling is able to represent the dynamic characteristics of the building with an acceptable level of accuracy, hence it can be used as a valid analysis tool to evaluate structural responses to dynamic loads.

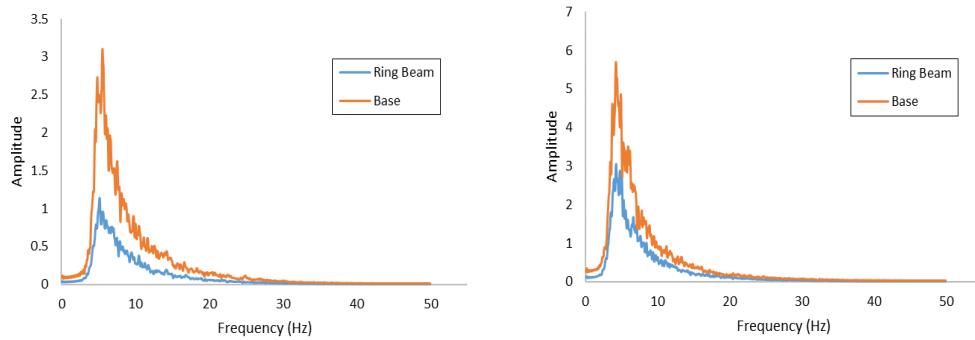
(a) Longitudinal dominant frequency graph (b) Transverse dominant frequency graph.

Figure 7. Dominant frequency graphic at House B**Spectrum Response**

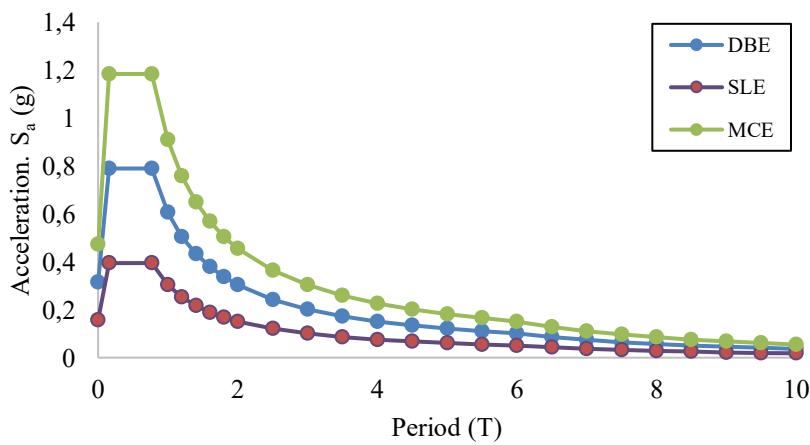
**Figure 8.** Combined response spectrum of earthquake variations at House A

The evaluation of building performance against earthquake loads is carried out by considering three levels of earthquake occurrence: Service Level Earthquake (SLE), Design Basis Earthquake (DBE), and Maximum Considered Earthquake (MCE). SLE represents an earthquake with a high probability of occurrence but low intensity, DBE is used as the basis for designing structures during their service life, while MCE describes the largest possible earthquake scenario with a minor probability. In the numerical analysis, each earthquake variation is modeled using the spectrum response method based on SNI 1726:2019 (see Figure 8 and Figure 10). This spectrum response data is derived through the S_{MS} multiplier coefficient (short-period spectrum acceleration) and S_{MI} (1-second spectrum acceleration), which depend on the seismic parameters of the test location. The application of this analysis aims to evaluate the capacity of the structure to withstand earthquake loads according to different levels of intensity. The results of the analysis are used to determine whether the building has performance that meets safety standards and whether reinforcement is needed to increase its resistance to severe earthquake scenarios.

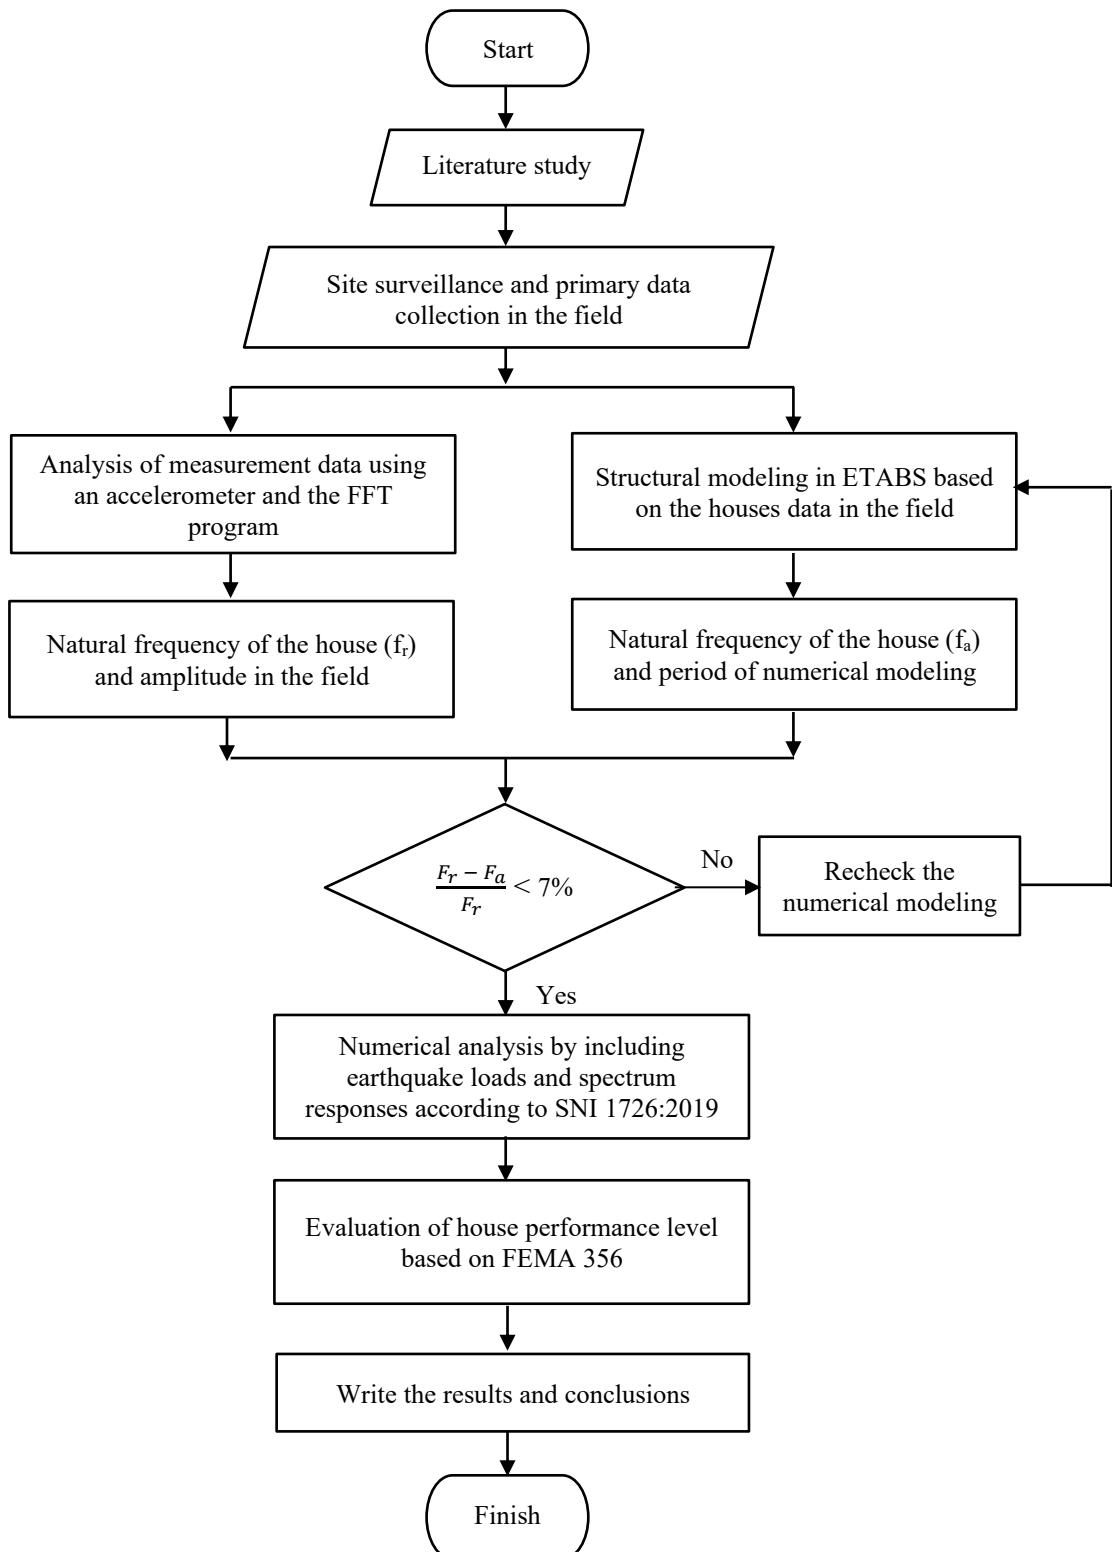
Figure 9. Research flowchart

The vibration recording data was processed using DewesoftX including a filtering process to reduce noise, before being analyzed using FFT to determine the natural frequencies of the building. The results were visualized in a frequency spectrum graph. Validation was carried out by comparing the results of field tests with numerical modeling, which includes natural frequencies. Furthermore, structural performance analysis was carried out on three earthquake variants, namely Service Level Earthquake (SLE), Design Basis Earthquake (DBE), and Maximum Considered Earthquake (MCE) based on FEMA 356 guidelines to evaluate the seismic capacity and performance of the building. Maximum ground acceleration (PGA_M) was calculated based on SNI 1726:2019, considering site factors and floor acceleration as the basis for evaluating the resistance of structures to earthquake loads. The research flow diagram can be seen in Figure 9.

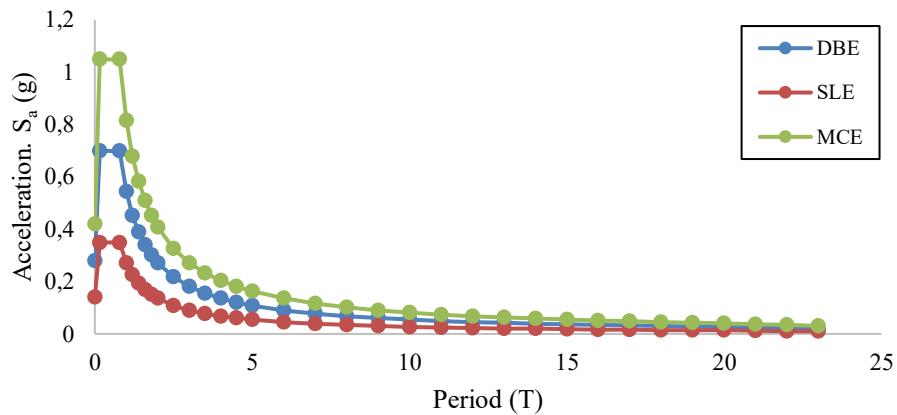
Figure 10. Combined response spectrum of earthquake variations at House B
Structural Displacement
