Characteristics of Slum Housing at TPA Suwung

Ni Putu Putri Puspita Dewi Sura, Ni Ketut Ayu Siwalatri, Ngakan Putu Sueca

Program Perencanaan dan Manajemen Pembangunan Desa dan Kota (PMDK), Program Magister
Arsitektur Universitas Udayana Bali, INDONESIA

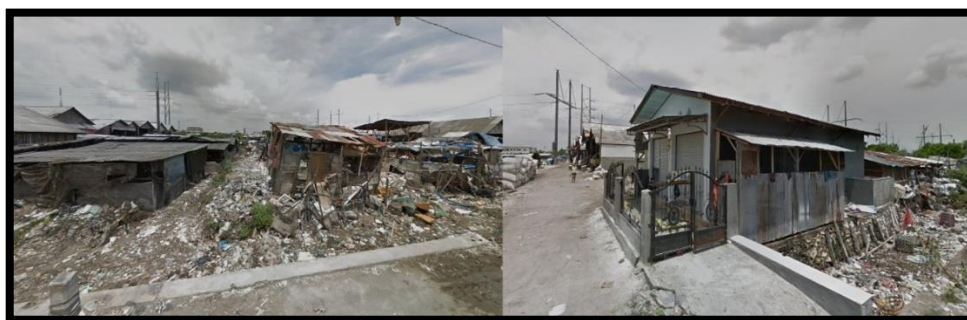
Figure 3. Occupancy at the Research Site (Observation Results, 2020)

The slums in Suwung TPA are dominated by buildings with uninhabitable conditions. The condition of buildings like this is often found on the eastern side of the Suwung TPA. The meaning of uninhabitable is housing that does not meet building safety standards, semi-plastered house floors, buildings with semi-permanent conditions, building roofs using asbestos and zinc, small and crowded buildings inhabited by many people, building density ranging from 70%-60%, and inadequate building health. Another characteristic of residential buildings in this area is the use of electric lighting from PLN with a power of 900 watts and illegal land status. Slums in Suwung TPA also have several areas with characteristics of adequate and livable residential buildings that meet building standards located on the west side of the Suwung TPA area.

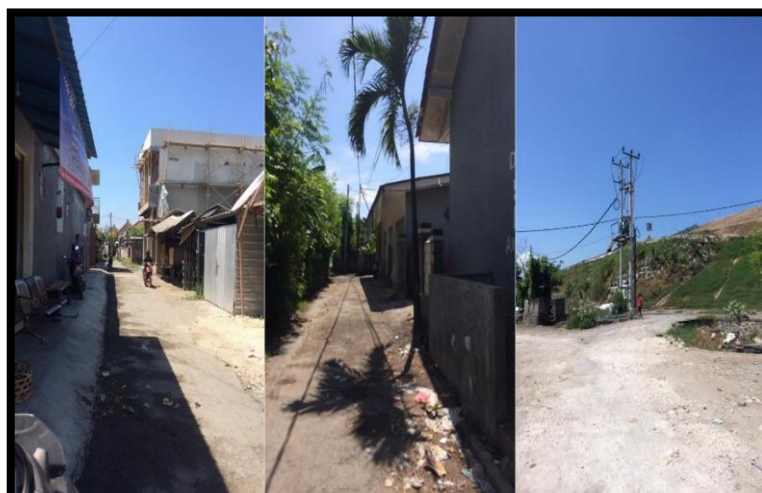
Figure 4. Environmental Road Conditions in Suwung TPA Slum Settlement (Observation Results, 2020)

TPA settlement has reached all corners of the area, but the quality of the road is poor with an inadequate area. Environmental roads use flexible pavement (asphalt) with potholes and cracks on the road surface at various angles. In some lanes still using limestone soil and in some other areas using paving stones with street lamp lighting. The results of field observations are listed in Table 1.

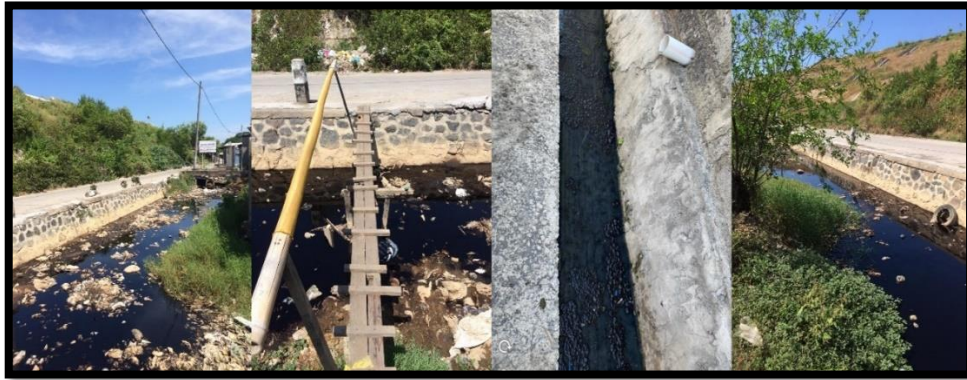
Figure 5. Drainage Conditions in Suwung TPA Slum Settlement (Observation Results, 2020)

The Suwung TPA is considered to be of concern with puddles of water caused by the drainage channel not functioning optimally. At some points there are no adequate drainage channels to support settlement conditions. The height of the puddle is >30 cm with an average inundation time of >2 hours, the frequency of inundation occurs >2 times a year. The results of the observations are shown in Table 3.

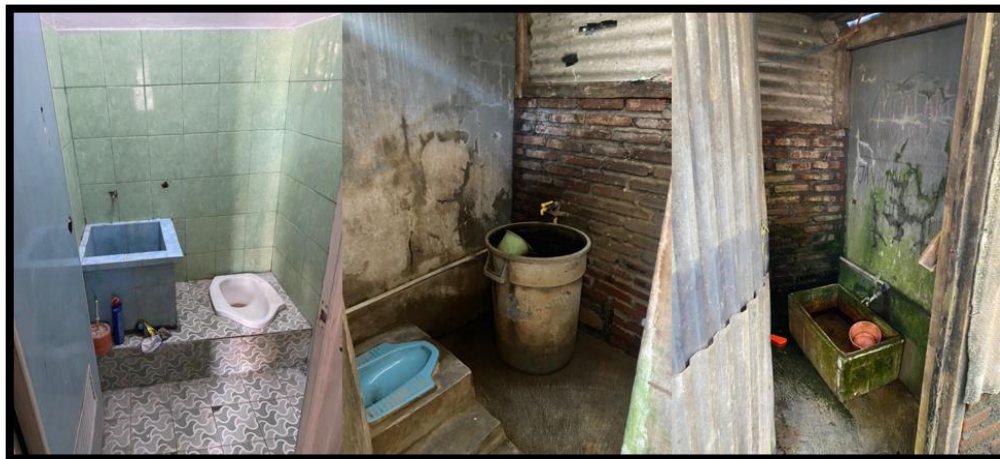
Figure 6. Wastewater Management Conditions in Suwung TPA Slum Settlement (Observation Results, 2020)

The condition of wastewater management in settlements is quite good and most residential buildings use private toilets. Some dwellings dispose of their household waste water carelessly. This can be seen from the absence of a drain for used dishwashing water that does not meet standards.

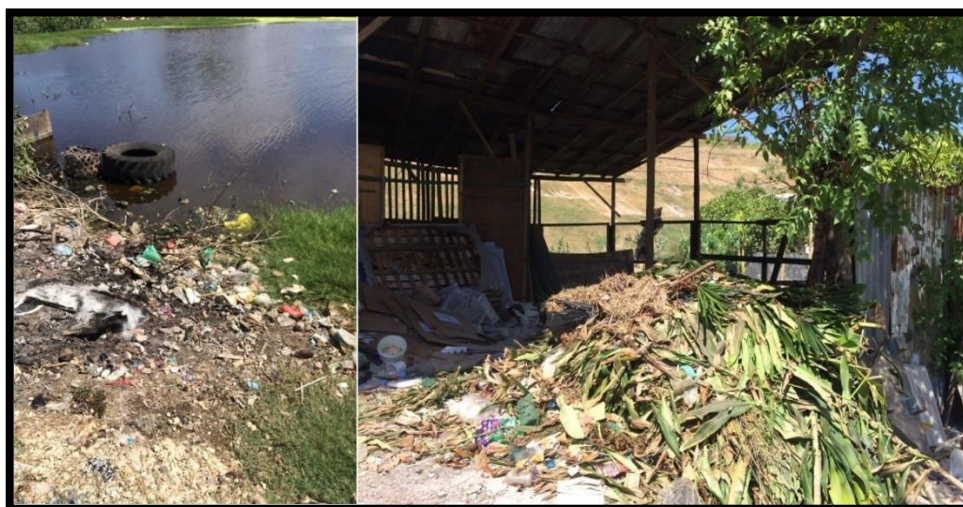
Figure 7. Waste Management Conditions in Suwung TPA Slum Settlement (Observation Results, 2020)

The results of observations and interviews in slums in Suwung TPA show that solid waste management is in a very bad condition. This situation can be seen from direct observations which show that there is no system of facilities and infrastructure for waste management. Garbage is only collected on the side of the road and on vacant land, dumped in drainage channels, burned, or placed on the banks of rivers, making conditions worse. Observations also show that the waste management facilities do not follow the standards.
